PLAY AREA SAFETY INSPECTION REPORT

Islington & Shoreditch Housing Association (ISHA) 02 May 2018

Site Name : ISHA - Vivian Comma Close

Date of Inspection: 02 May 2018
Inspected by: David Owen

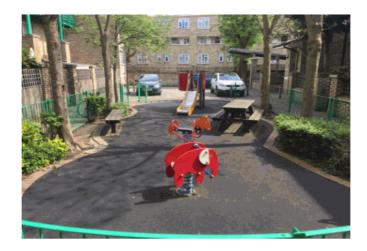
Maintenance on ttge Multiplay unit is not what is should be to keep the play equipment up to standard.

The present overall risk rating for the play space is HIGH

If works and recommendations are undertaken the risk may be reduced.
