Fire Risk Assessment

1-20 Salisbury House

Version 2

10 December 2020

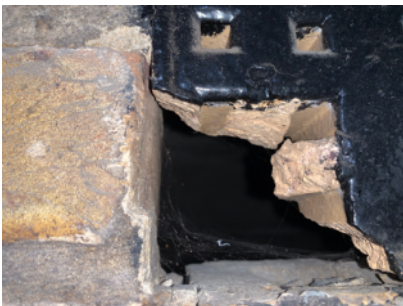
Broken grill above intake cupboard door.

Cable penetrations in the electrical cupboard require fire stopping. There is also a grill above this door which is broken and it is apparent that the cupboard is not fire stopped at this point. This should be properly fire stopped and it should be confirmed that all pipe and cable penetrations in this location are also properly fire stopped.

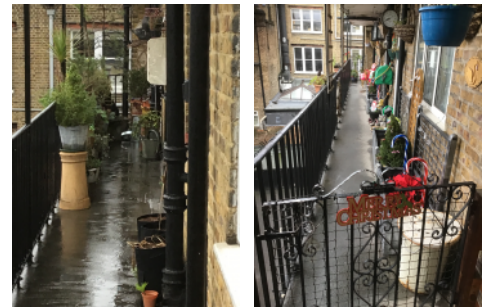
There is a significant number of items located in the common areas, which may present a trip hazard and/or obstruction in the event of a fire. Whilst it is appreciated that in the most part these items have been placed with the good intention of raising the aesthetics and appearance of the balconies and external areas of the building, these are to an unacceptable level. Residents should be asked to limit the number of items and these areas should be monitored to ensure they do not build up.

Source Version	1
Category	Escape Routes & Fire Spread
Sub Category	Ease of Use
Action Required	Obstructions should be removed from the escape routes in the following locations: There is a significant number of items located in the common areas, which may present a trip hazard and/or obstruction in the event of a fire. Whilst it is appreciated that in the most part these items have been placed with the good intention of raising the aesthetics and appearance of the balconies and external areas of the building, these are to an unacceptable level. Residents should be asked to limit the number of items and these areas should be monitored to ensure they do not build up. (1st 2nd and 3rd floor balconies).
Priority	Medium
Status	Identified
Owner	Neighbourhood Services
Due Date	6 January 2021
