Fire Risk Assessment

Victor Cazalet House

Version 2

4 December 2020

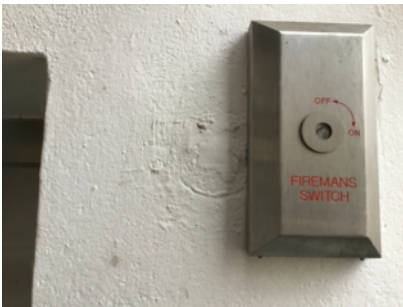
The firefighting lift control was not tested during this inspection, however, ISHA and the Neighbourhood Officer has confirmed all testing and maintenance of fire safety measures is up to date.

Firefighters switch to lift (not tested during this inspection)

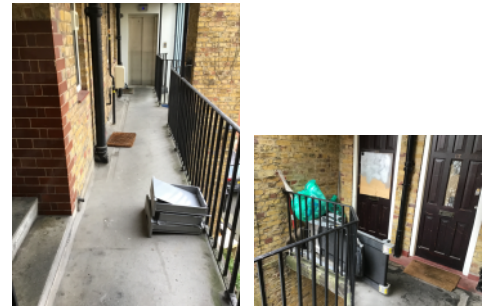
Task 1

Source Version	1
Category	Escape Routes & Fire Spread
Sub Category	Ease of Use
Action Required	Obstructions should be removed from the escape routes in the following locations: 2nd, 3rd and 4th floor balconies.
Priority	Medium
Status	Identified
Owner	Neighbourhood Services
Due Date	6 January 2021

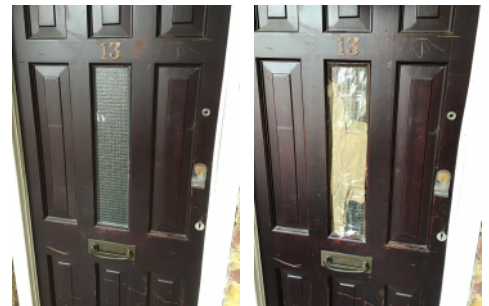
Task 2

Source Version	1
Category	Escape Routes & Fire Spread
Sub Category	Construction and Glazing
Action Required	Replace the damaged vision panel in the following door with glazing which will afford 30 minutes of fire resistance (integrity only): Flat 13.
Priority	Medium
Status	Completed
Owner	Customer Homes
Due Date	6 January 2021

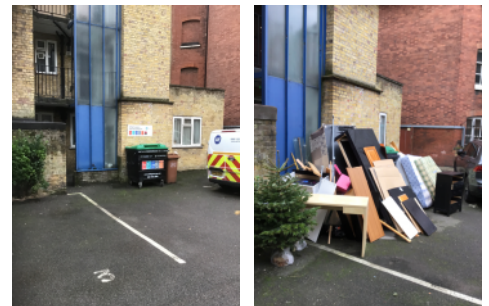
Task 4

The bin store is unsecured

Source Version	1
Category	Fire Prevention
Sub Category	Arson
Action Required	Do not store combustibile materials adjacent to the building. Bin store unsecured, with the addition of a large quantity of combustibile items located up against the building on the ground floor.
Priority	High
Status	Completed
Owner	Neighbourhood Services
Due Date	8 July 2020

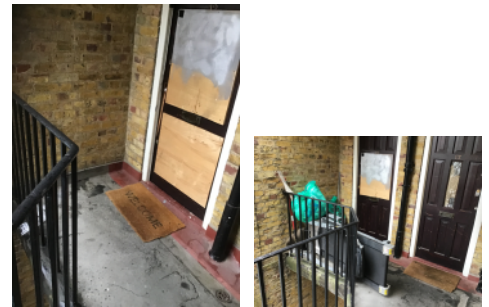
Task 6

Source Version	1
Category	Fire Prevention
Sub Category	Housekeeping
Action Required	The storage of combustible items in communal areas is excessive and should be reduced. 3rd floor, outside flat 12.
Priority	Medium
Status	Completed
Owner	Neighbourhood Services
Due Date	6 January 2021

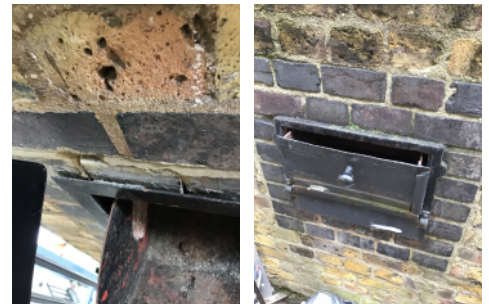
Task 7

There is a rubbish chute provided serving all floors, however, it is in a state of ill repair. The hatch on the 4th floor is rusted and does not close completely. Other hatches are cracked and loose from the brickwork. These should be serviced and repaired accordingly.

Source Version	1
Category	Escape Routes & Fire Spread
Sub Category	Dampers, Ducts and Chutes
Action Required	Repair the refuse chute hatches in the following locations, to afford 30 minutes of fire resistance: 1st floor (jamming open) 2nd floor 3rd floor (loose from brickwork) 4th floor
Priority	Medium
Status	Identified
Due Date	6 January 2021

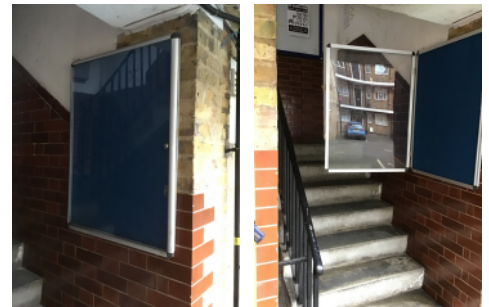
Task 9

The notice board at the base of the staircase is broken and does not close securely. It was found to be open at time of inspection and could cause an obstruction to escaping persons using the staircase. This should be repaired.

Source Version	1
Category	Escape Routes & Fire Spread
Sub Category	Ease of Use
Action Required	The notice board at the base of the staircase is broken and does not close securely. It was found to be open at time of inspection and could cause an obstruction to escaping persons using the staircase. This should be repaired.
Priority	Low
Status	Completed
Owner	Neighbourhood Services
Due Date	6 January 2022

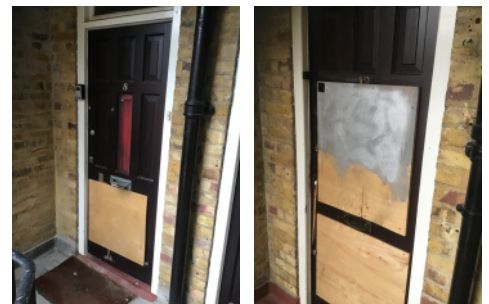
Task 10

There is damage to the doors to flats 8 and 12 which, although a temporary repair has been made, would undoubtedly affect their fire resistance. However, these doors are located at the end of their respective balconies and therefore are not required to be fire resisting, although it is always good practice to ensure all flat entrance doors are in a good state of repair.

Source Version	1
Category	Escape Routes & Fire Spread
Sub Category	Fire Doors
Action Required	Replace the following doors with FD30 self-closing doors: Flat 12 Flat 8
Priority	Medium
Status	Identified
Owner	Customer Homes
Due Date	6 January 2021

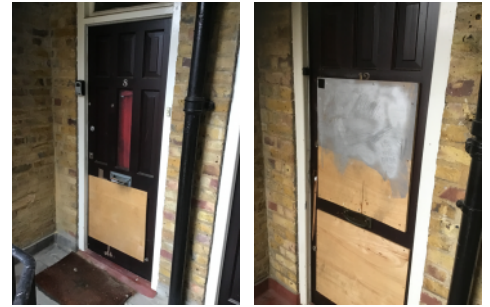
Task 11

Source Version	1
Category	Escape Routes & Fire Spread
Sub Category	Fire Doors
Action Required	Replace the following doors with FD30 self-closing doors: Flat 12 Flat 8
Priority	Medium
Status	Identified
Owner	Customer Homes
Due Date	6 January 2021
