Fire Risk Assessment

14-19 Canonbury Court

Version 4

29 August 2023

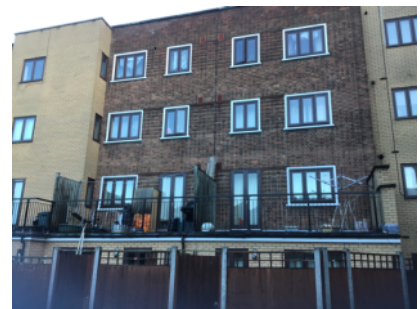
Rear elevation- brick/mortar walls, private balcony on 1st floor.

Brick/mortar external walls- no additional combustible external wall systems evident within the scope of this FRA.

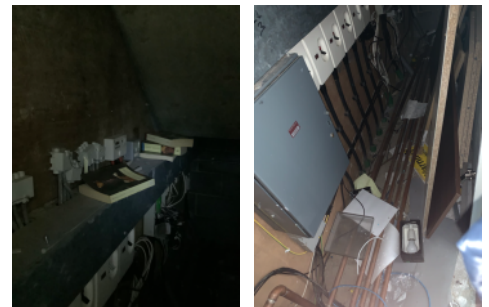
Task 5

Combustibles found in electrical cupboard.

Source Version	1
Category	Fire Prevention
Sub Category	Housekeeping
Action Required	The storage of combustible items in electrical cupboards should be prohibited. 29/08/23 This task is still outstanding.
Priority	High
Status	Identified
Owner	Neighbourhood Services
Due Date	5 June 2020
