**Fire Risk Assessment**

**15A-B Queensdown Road**

Version 4

9 October 2023

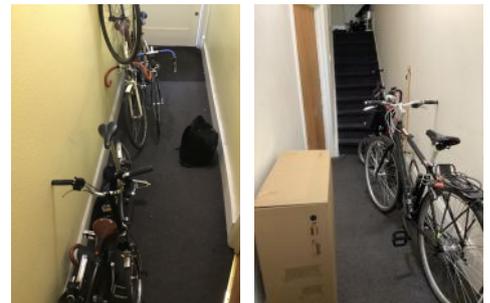
### Task 3

Access was gained into the upper flat which has an entrance door fitted to FD30S standard. The self closing device (external) is defective and should be repaired. The internal doors which open onto the entrance hallway of this flat are not fire resisting.

Repair the self-closing device on the following doors:
