Fire Risk Assessment

Vivian Comma Close, 2-4

Version 3

31 July 2023

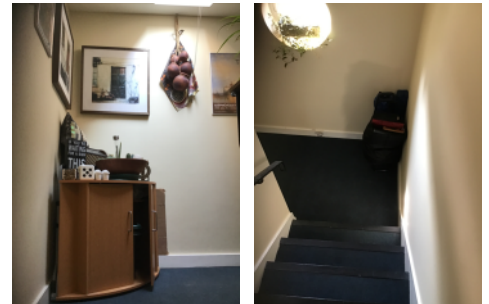
Task 1

The building was found to be generally well maintained and clear of combustable items in common parts, except for the 2nd floor landing where there was an unacceptable amount of obstructions and combustible items.

The storage of combustible items in communal areas is excessive and should be reduced.

Source Version	1
Category	Fire Prevention
Sub Category	Housekeeping
Action Required	The storage of combustible items in communal areas is excessive and should be reduced.
Priority	Medium
Status	Identified
Owner	Neighbourhood Services
Due Date	23 December 2020
