Fire Risk Assessment

31 Hillmarton Road

Version 2

12 October 2023

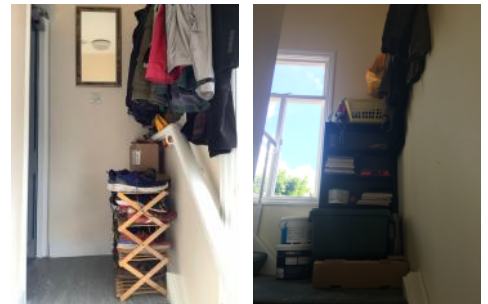
Task 2

Source Version	1
Category	Fire Prevention
Sub Category	Housekeeping
Action Required	The storage of combustible items in escape routes should be prohibited.
	There was a significant volume of combustible materials found in the common parts, on all floors which should be removed.
	12/10/2023 This task remains outstanding.
Priority	High
Status	Identified
Owner	Customer Homes
Due Date	14 September 2020
