Fire Risk Assessment

34-35 Vivian Comma Close

Version 3

9 October 2023

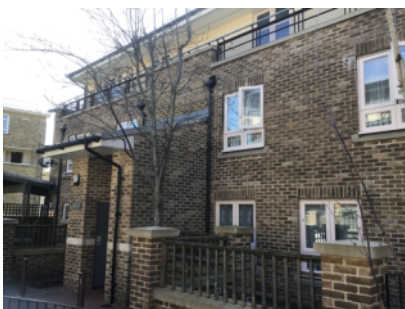
External walls front elevation.

External walls are of brick/mortar construction. There is some render applied to the second floor external walls, the substrate to which this render has been applied cannot be confirmed within the scope of this fire risk assessment.

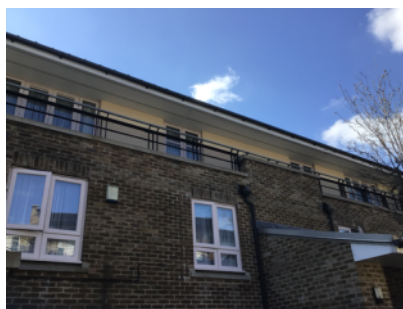
Small terraced area accessed from second floor flats.

It appears that each flat has accessed via patio doors onto a small private terraced area. However there is no protruding deck.
