**Fire Risk Assessment**

**38-39 Vivian Comma Close**

Version 3

9 October 2023

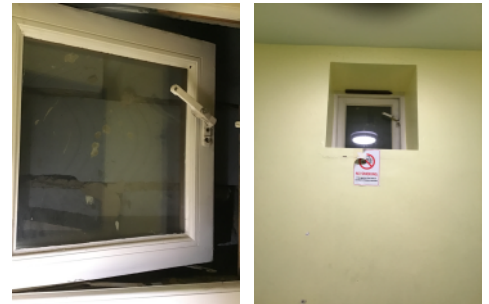
## Task 1

Source Version	1
Category	Escape Routes & Fire Spread
Sub Category	Smoke Ventilation
Action Required	There is a small openable window at the top of the stairs, however, there is a block wall in such close proximity to this building and this window, that it cannot be confirmed within the scope of this risk assessment whether this window does access open air. This is the only means of ventilating this staircase and therefore some exploratory measures should be taken to confirm whether this window would provide any ventilation in the event of a fire.
Priority	High
Status	Identified
Owner	Customer Homes
Due Date	4 August 2020
