**Fire Risk Assessment**

**39-47 Wilton Place**

Version 3

7 August 2023

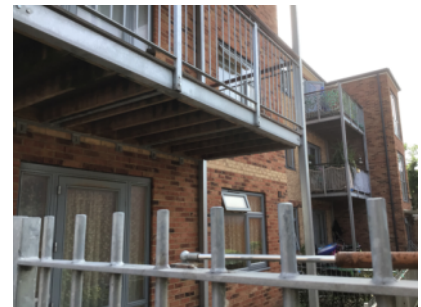
External walls - front elevation

External walls are of a brick/mortar construction on all elevations, with no additional external wall systems visible.
