Fire Risk Assessment

5-8 Canonbury Court

Version 4

29 August 2023

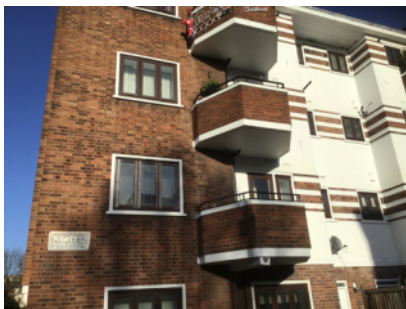
External walls front elevation.

Original brick/mortar external walls, with small areas of render applied to the external walls of the staircase at the rear elevation, and render applied to sections of the first second and third floors of the front elevation.

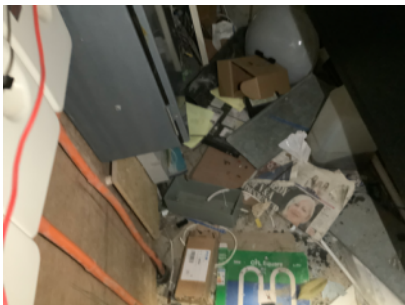
There are combustible items within the electrical cupboard.

Combustibles in the electrical cupboard

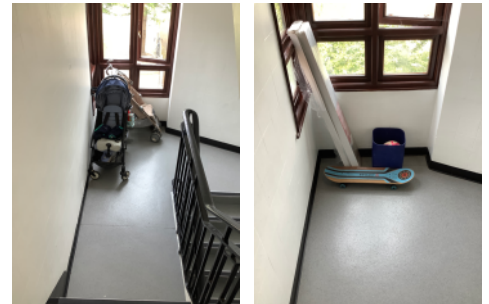
Task 1

There are some pot-plants and other items on the 3rd floor that may present an obstruction for escaping persons. A pram was noted on the staircase on the 1st floor landing.

Source Version	1
Category	Escape Routes & Fire Spread
Sub Category	Ease of Use
Action Required	Obstructions should be removed from the escape routes in the following locations: There are some pot-plants and other items on the 3rd floor that may present an obstruction for escaping persons. VERSION 3: This task has not been completed, and therefore remains as an identified task within this version of the FRA. The date that the original task was generated remains unchanged. 29/08/23 This task is still outstanding.
Priority	Medium
Status	Identified
Owner	Neighbourhood Services
Due Date	4 December 2020

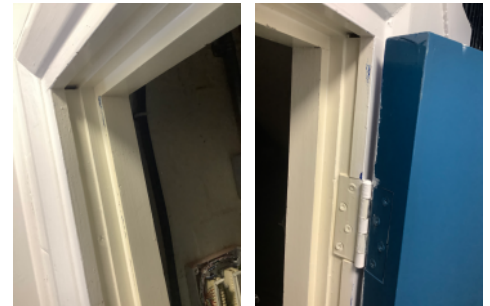
Task 4

The electrical cupboard door should have intumescent strips and cold smoke seals fitted.

Source Version	1
Category	Escape Routes & Fire Spread
Sub Category	Fire Doors
Action Required	Install intumescent strips and smoke seals on the following doors: The electrical cupboard door.
	VERSION 3: This task has not been completed, and therefore remains as an identified task within this version of the FRA. The date that the original task was generated remains unchanged.
	29/08/23 This task is still outstanding.
Priority	Low
Status	Identified
Owner	Customer Homes
Due Date	4 December 2021
