Fire Risk Assessment

29-31 Canonbury Court

Version 5

23 August 2024

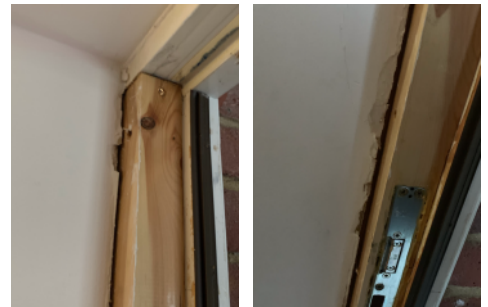
Source Version	1
Category	Escape Routes & Fire Spread
Sub Category	Construction and Glazing
Action Required	<p>Provide fire stopping around the door frame at the following locations:</p> <p>Inspection of a sample flat entrance door (flat 29), revealed fire stopping concerns around the frame. It should be ensured that all flat entrance doors have complete door sets which afford an FD30S SC standard of fire resistance. That is to include the door leaf, door furniture and ironmongery and door frame.</p> <p>VERSION 3: This task has not been completed, and therefore remains as an identified task within this version of the FRA. The date that the original task was generated remains unchanged.</p> <p>29/08/23 This task is still outstanding.</p> <p>23/08/24 It was not possible to gain access to flat 29 and confirm if this has been completed so remains identified.</p>
Priority	High
Status	Identified
Owner	Neighbourhood Services

Due Date	10 June 2020

6	Escape Routes & Fire Spread	Construction and Glazing	<p>Provide fire stopping around the door frame at the following locations:</p> <p>Inspection of a sample flat entrance door (flat 29), revealed fire stopping concerns around the frame. It should be ensured that all flat entrance doors have complete door sets which afford an FD30S SC standard of fire resistance. That is to include the door leaf, door furniture and ironmongery and door frame.</p> <p>VERSION 3: This task has not been completed, and therefore remains as an identified task within this version of the FRA. The date that the original task was generated remains unchanged.</p> <p>29/08/23 This task is still outstanding.</p> <p>23/08/24 It was not possible to gain access to flat 29 and confirm if this has been completed so remains identified.</p>	High	Identified
---	--------------------------------	-----------------------------	--	------	------------

Inspection of a sample flat entrance door (flat 29), revealed fire stopping concerns around the frame.

Inspection of a sample flat entrance door (flat 29), revealed fire stopping concerns around the frame. It should be ensured that all flat entrance doors have complete door sets which afford an FD30S SC standard of fire resistance. That is to include the door leaf, door furniture and ironmongery and door frame.
