Fire Risk Assessment

278 Forest Rd, Flats 1-10

Version 5

26 September 2024

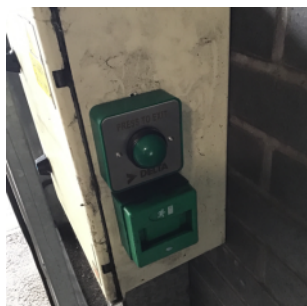
Version 3 - The key opening mechanism on the car park gate has been replaced with a mushroom button device.

New mushroom button device

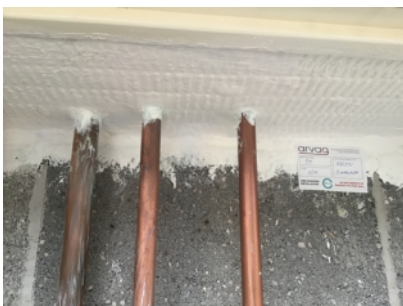
It is evident that a recent programme of fire stopping has been undertaken in this building (11/19), to an acceptable standard. However, whilst some cable penetrations have been fire stopped within the electrical cupboard on the ground floor, there is a large hole in the corner where a number of cables pass which is not adequately fire stopped.

Evidence of recent fire stopping.
