## **Fire Risk Assessment**

**1-16 Penn Street**

Version 8

30 August 2024

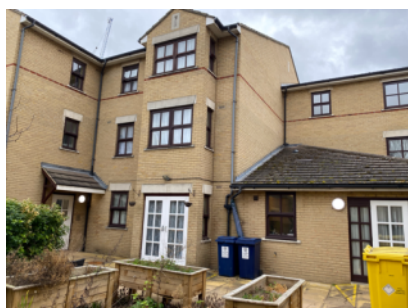
Rear elevation of the building.

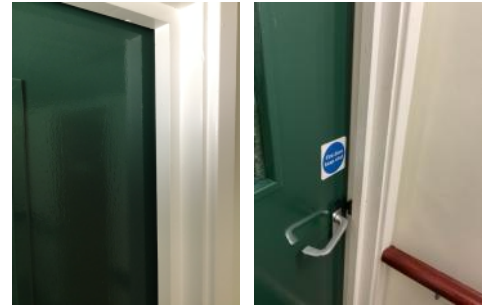
Source Version	2
Category	Escape Routes & Fire Spread
Sub Category	Fire Doors
Action Required	<p>Adjust the self-closing device on the following doors:</p> <p>The corridor door outside the ground floor kitchen is not closing fully into its frame.</p> <p>Version 6. 21/9/22 This task is not complete.</p> <p>Version 8, 30/08/2024 This task remains outstanding. Not sufficient power to close as latch prevents door closing.</p>
Priority	Medium
Status	Identified
Owner	Customer Homes
Due Date	28 July 2020

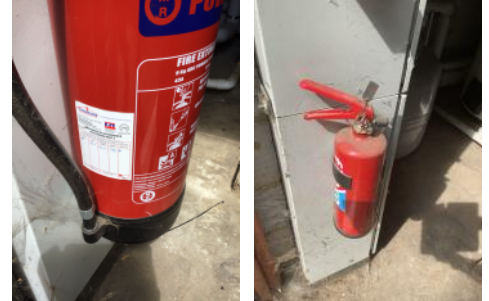
### Task 4

Source Version	2
Category	Fire Management
Sub Category	Testing & Maintenance
Action Required	<p>The dry powder extinguisher in the boiler room has not been tested within the last 12 months and should therefore be tested without delay.</p> <p>Version 6. 21/9/22 It was not possible to ascertain the last date of inspection for the boiler room fire extinguisher.</p> <p>Version 8, 30/08/2024 There was a different fire extinguisher to the previous picture, but no record of inspection present. This task remains outstanding.</p>
Priority	Medium
Status	Identified
Owner	Customer Homes
Due Date	28 July 2020

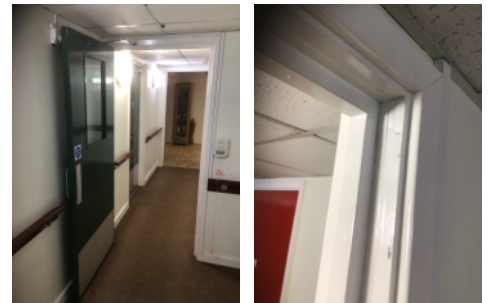
## Task 8

Source Version	5
Category	Escape Routes & Fire Spread
Sub Category	Fire Doors
Action Required	Install intumescent strips and smoke seals on the following doors:  Cross corridor door through to the kitchen and dining room area on the ground floor.  Version 6. 21/9/22 This task is not complete.  Version 8, 30/08/2024 This task remains outstanding.
Priority	Medium
Status	Identified
Owner	Customer Homes
Due Date	14 September 2021
