## **Fire Risk Assessment**

### **1-5 Sojourner Close**

Version 4

15 August 2024

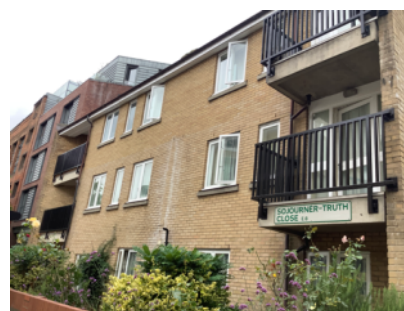
Brick/mortar external walls, - end elevation
