Fire Risk Assessment

1-7 Thomas Cromwell Court

Version 4

27 August 2024

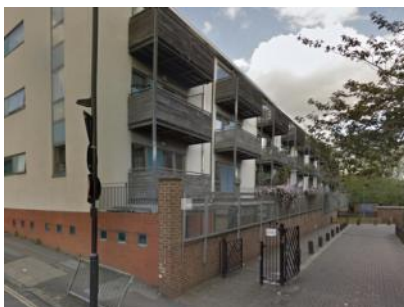
Private balconies to the rear of the property

There are private balconies to the rear of the property which are constructed of a steel frame with what appears to be hardwood decking.

Whilst beyond the scope of the Fire Safety Order, as a private balcony is not part of the common area, residents should be advised about the risks arising from the presence of combustible materials on balconies and it should be made clear that smoking, the use of barbecues and storage of flammable property on balconies can increase that risk. Advice from fire and rescue authorities is also clear that barbecues should not be used on balconies.

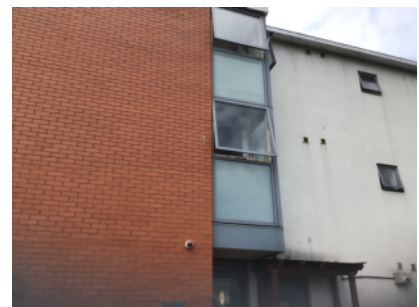
External walls, part brick, part rendered.

This building is of a brick/mortar construction with a rendered finish over the majority of the external walls overall floors.

The substrate to which this render has been applied cannot be confirmed within the scope of this fire risk assessment although it does appear to be directly over the brickwork.

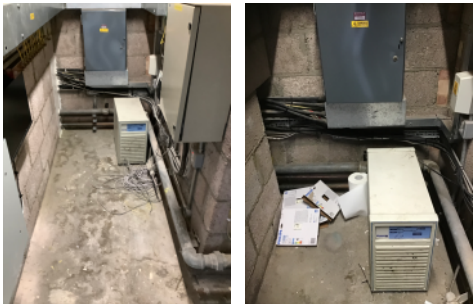
Source Version	1
Category	Fire Prevention
Sub Category	Housekeeping
Action Required	<p>The storage of combustible items in electrical cupboards should be prohibited.</p> <p>Version 4, 27/08/2024 This has been retasked as old power unit pictured is still present along with further combustibles.</p>
Priority	Medium
Status	Identified
Owner	Neighbourhood Services
Due Date	22 February 2021
