**Fire Risk Assessment**

**11-22 Trays Hill Close**

Version 5

20 September 2024

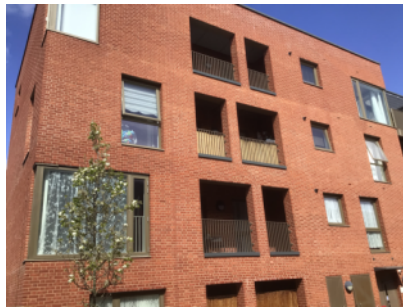
Showing external walls with balconies front elevation

External walls are predominantly of brick and mortar construction and all external elevations, with the exception of a section of tiled facade on the third floor.
