Fire Risk Assessment

Walters House

Version 4

7 September 2023

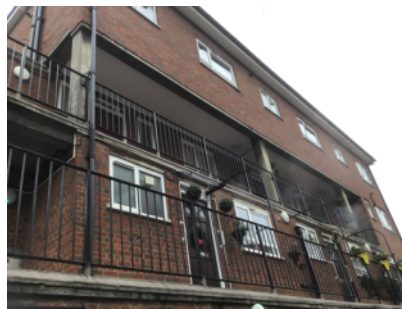
Brick/mortar external walls

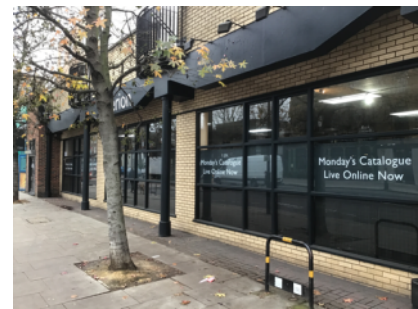
Auction house, occupying ground floor of building.

Of particular concern is the level of fire separation between the ground floor commercial level, and the flats occupying the floors above. The complete ground floor footprint of the building is occupied by an auction house, and access into this part of the building revealed an extremely high fire loading from furniture and a high volume of other combustible items. Discussion with the tenants in the auction house revealed that there is often water leakage into this floor from the levels above. Considering then that the compartment floor above the ground floor is not imperforate to water, it is reasonable to assume it is not imperforate to the passage of smoke and should a fire occur in this area then there is a risk of smoke and/or heat spread into the flats above.

Liaison with the landlord/agent controlling the ground floor of the building should be made to ensure a compartment survey has been carried out which confirms adequate compartmentation is provided between the auction house on the ground floor and the flats above.

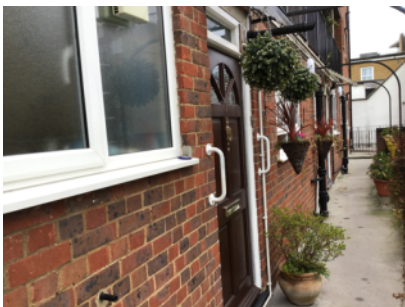
There are glazed fanlights and vision panels in flat entrance doors and glazing to flat windows, however these are all above 1.1m from their respective balcony decks so is not required to be FR.

Windows, fanlights and vision panels above 1.1m

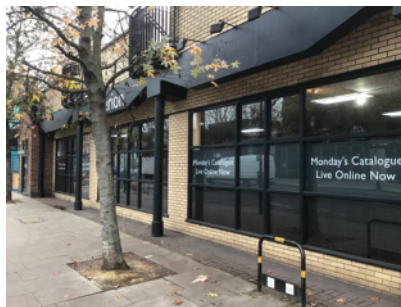
There is concern regarding the level of fire separation provided between the ground floor (commercial section) and the flats occupying the upper floors. Liaison with the owner/agent of the ground floor section of the building should be made to ensure a compartmentation survey confirms adequate (60 minutes) FR compartmentation is provided.

Auction House occupying the ground floor level of the building.

8	Escape Routes & Fire Spread	Construction and Glazing	<p>There is concern regarding the level of fire separation provided between the ground floor (commercial section) and the flats occupying the upper floors. Liaison with the owner/agent of the ground floor section of the building should be made to ensure a compartmentation survey confirms adequate (60 minutes) FR compartmentation is provided.</p> <p>07/09/2023 No evidence present to confirm this task has been completed so this remains identified.</p>	High	Identified
---	-----------------------------	--------------------------	---	------	------------

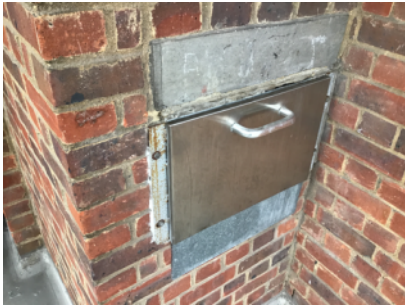
Well fitted, appropriate standard, rubbish chute hatch.
