# PLAY AREA SAFETY INSPECTION REPORT

# Islington & Shoreditch Housing Association (ISHA)

Site Name: ISHA - Canonbury Court

Date of Inspection: 02 May 2018
Inspected by: David Owen

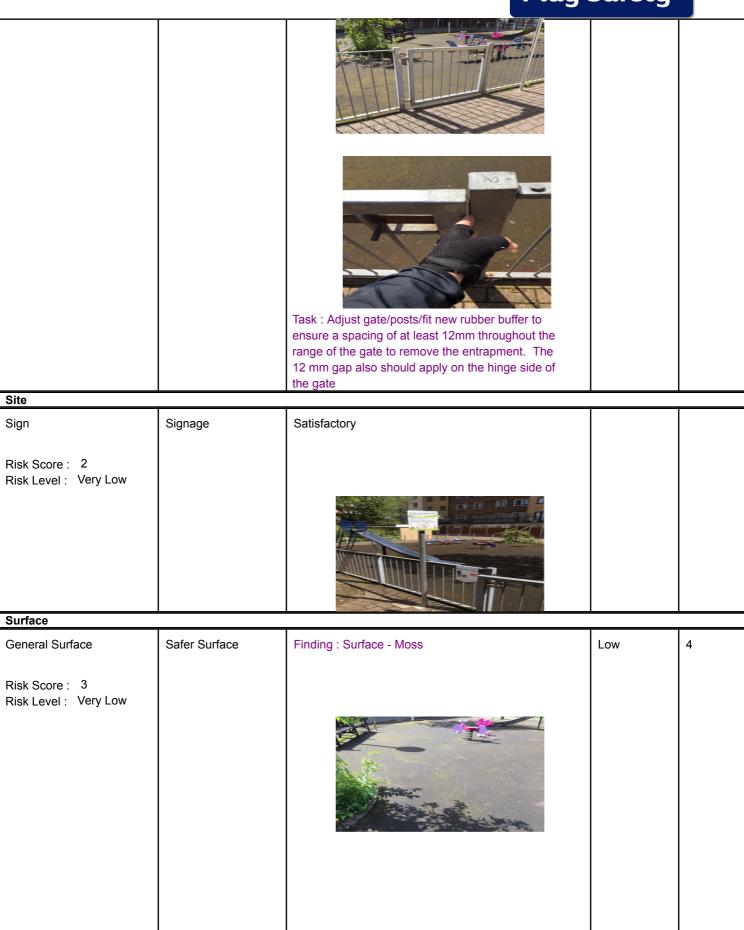
Notes: Latch does not fit in to the slot as the gate post dropped - replace worn hinge bolt.  Task: Refer to Inspection Notes / Description		
Gates x 2	Entrance - Dog Proof	Finding : Item - Missing	Low	7
Risk Score: 4 Risk Level: Low	.,			
		Notes: Both gate stoppers missing / removed, leaving sharp sections of welds on the gate - repair.		
		Task: Replace item		
Gates x 2	Entrance - Dog Proof	Finding : Entrapment on side(s) of gate	Medium	8
Risk Score: 4 Risk Level: Low
